MECHANICAL CLEANSING SERVICES LIMITED

Case Study: Local Swimming Baths

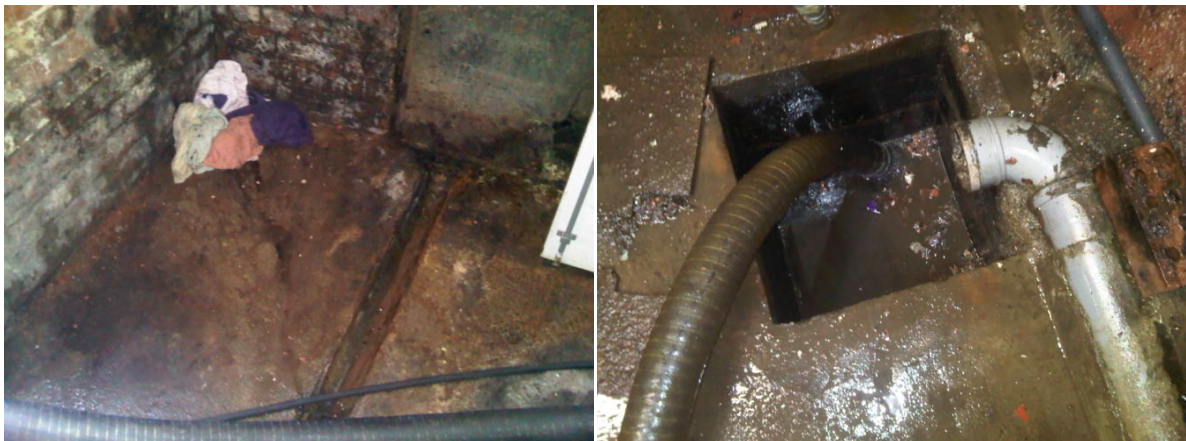
This local swimming baths was situated below the water table. The boilers were located on the ground floor and the pumps were located in the basement. A boiler cracked leaking a substantial volume of heating fuel which travelled through the surrounding walls with ground water and into the basement. The oil was automatically pumped out via a sump pump directly into the foul water system.

Heavy rainfall increased the level of ground water which aided the oil's migration into the basement.

MCS responded to the spill and immediately stopped any more oil being pumped out into the foul water. A temporary interceptor was installed to intercept any further oil migrating through the wall.

All areas were thoroughly cleaned and all contaminants were disposed accordingly.

The interceptor remained in use until all of the leaked oil had migrated from the surrounding walls and was safely stored for collection.
